**Coal Combustion Waste Impoundment
Round 6 - Dam Assessment Report**

Vermilion Power Station (Site 015)

Fly Ash Dikes

Dynegy Midwest Generation, Inc.
Oakwood, Illinois

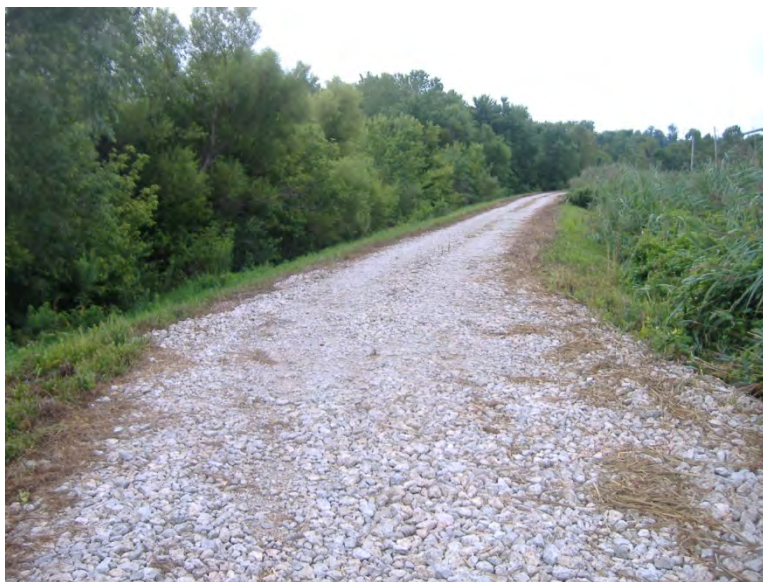
The crest of the embankment had no signs of significant depressions, tension cracks or other indications of settlement or shear failure. A gravel service road covered the majority of the embankment. Figure 5.2.1-1 shows the typical crest conditions.

Figure 5.2.1-1: Photograph of Crest of North Ash Pond System Embankment

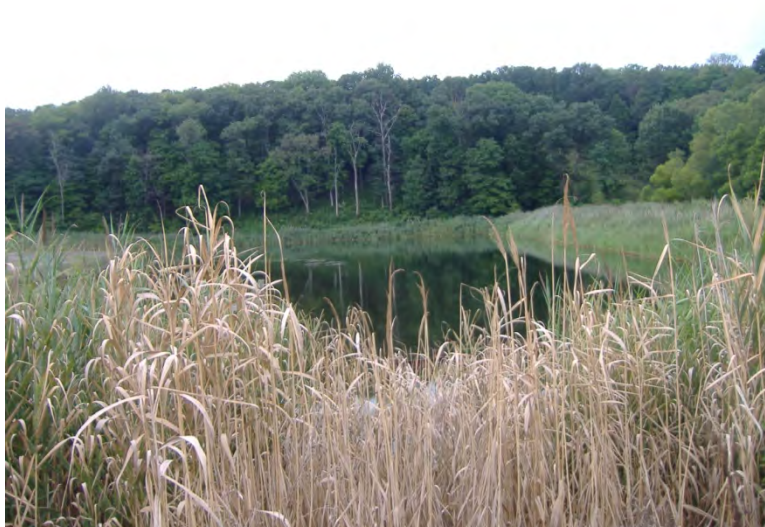
The inside slope of the North Ash Pond System embankment is vegetated with various species of tall grass and weeds. Heavy overgrowth in the primary cell of the North Ash Pond System made close observation of embankment conditions difficult. There were no observed scarps, sloughs, bulging, cracks, depressions or other indications of slope instability. Figure 5.2.2-1 shows a representative section of the inside slope of the primary cell embankment. Figure 5.2.2-2 shows a representative section of the inside slope of the secondary cell embankment.

Figure 5.2.2-1: Photograph of the Inside Slope of the North Ash Pond System Primary Cell Embankment

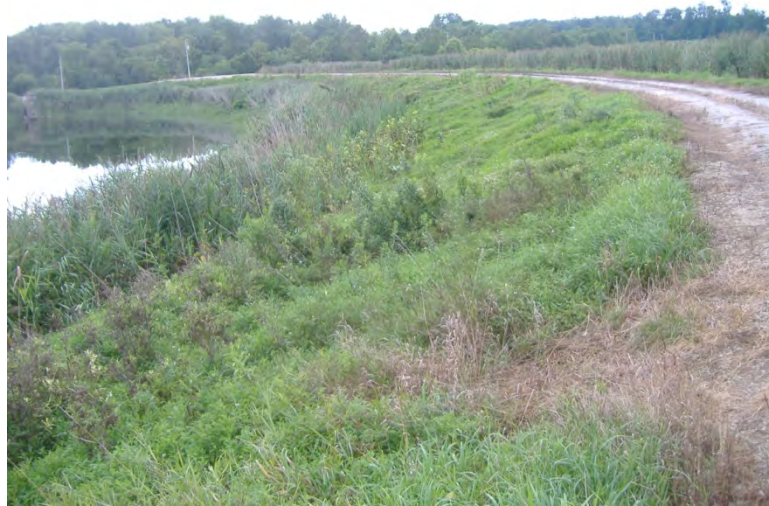
Figure 5.2.2-2: Photograph of the Inside Slope of the North Ash Pond System Secondary Cell Embankment

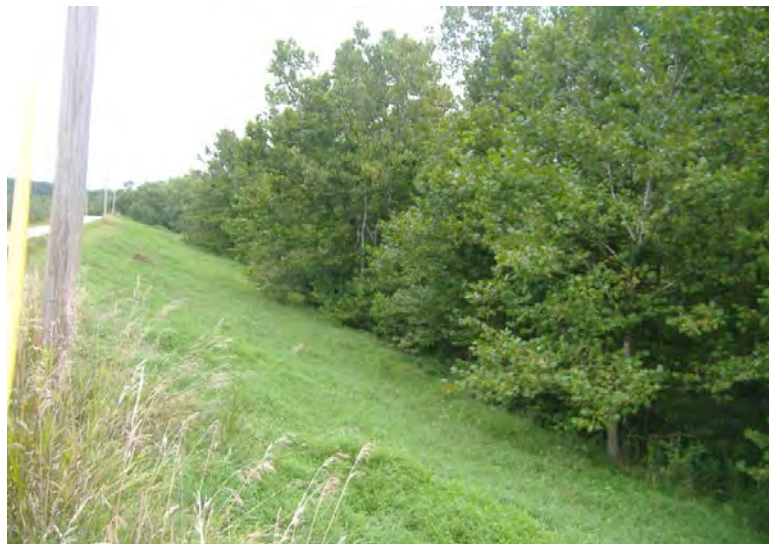
The outside slope of the embankment is vegetated with various species of tall grass and weeds. No major scarps, sloughs, bulging, cracks, depressions or other indications of slope instability, or signs of uncontrolled seepage were observed. Figure 5.2.3-1 shows a representative section of the outside slope of the embankment.

Figure 5.2.3-1: Photograph of the Outside Slope of the North Ash Pond System Embankment.

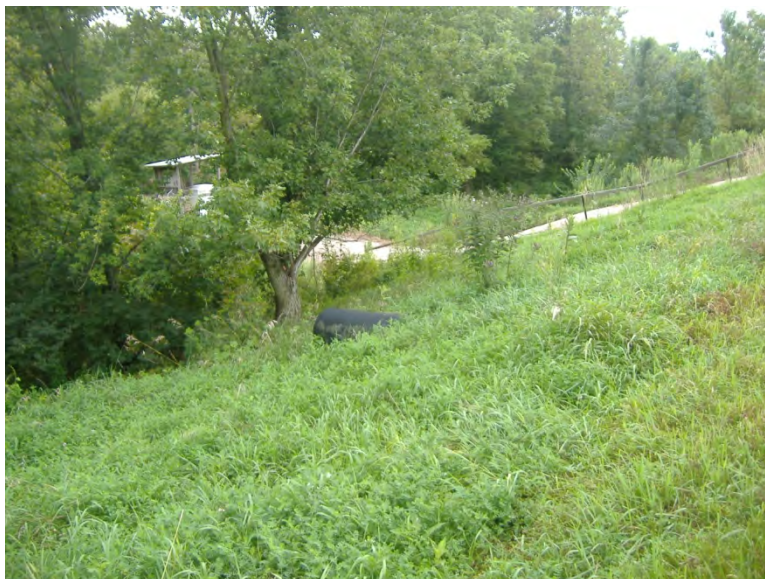
One large tree was observed near the emergency spillway of the North Ash Pond System. Figure 5.2.3-2 shows the tree.

Figure 5.2.3-2: Photograph of Large Tree Near Emergency Spillway on North Ash Pond System Embankment.

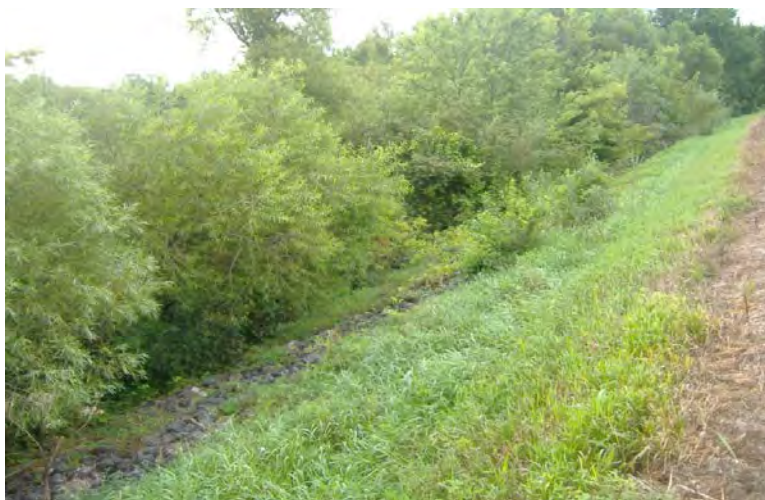
Most of the toe of the embankment is densely vegetated with various species of trees, grass, and weeds. In some sections, the toe is also armored with riprap. Figure 5.2.3-3 shows a portion of the toe that is armored with riprap and also covered in dense vegetation.

Figure 5.2.3-3: Photograph of Riprap and Dense Vegetation at the Toe of the North Ash Pond System Embankment.

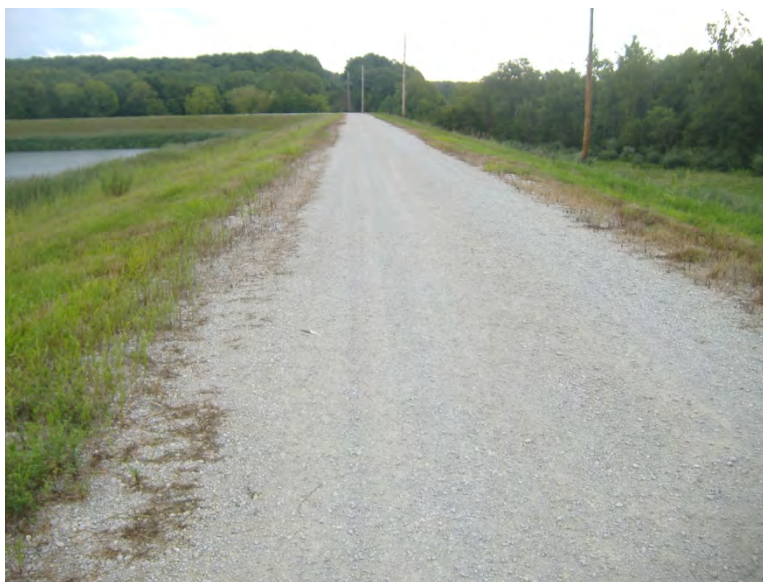
The crest of the embankment had no signs of significant depressions, tension cracks or other indications of settlement or shear failure. Figure 5.3.1-1 shows the typical crest conditions.

Figure 5.3.1-1: Photograph of the Crest of the East Ash Pond System Embankment.

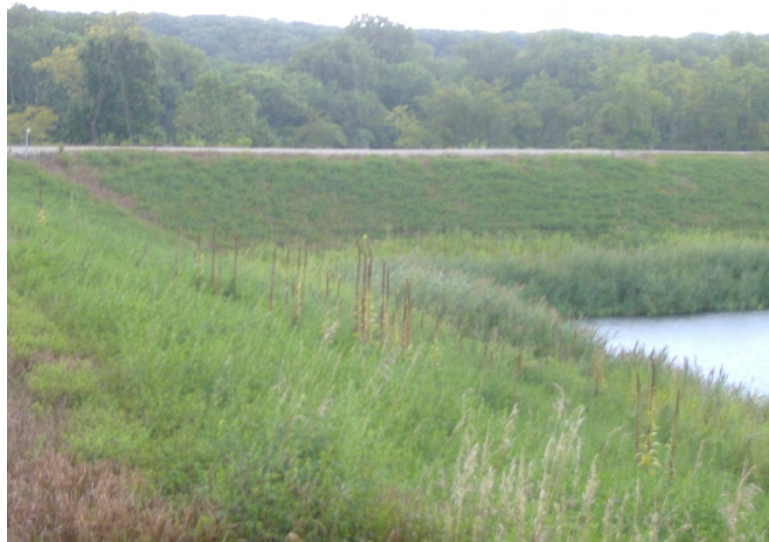
The inside slope of the East Ash Pond System embankment is vegetated with various species of tall grass and weeds. There were no observed scarps, sloughs, bulging, cracks, depressions or other indications of slope instability. Figure 5.3.2-1 shows a representative section of the inside slope of the primary cell embankment. Figure 5.3.2-2 shows a representative section of the inside slope of the secondary cell embankment.

Figure 5.3.2-1: Photograph of the Inside Slope of the East Ash Pond System Primary Cell Embankment.

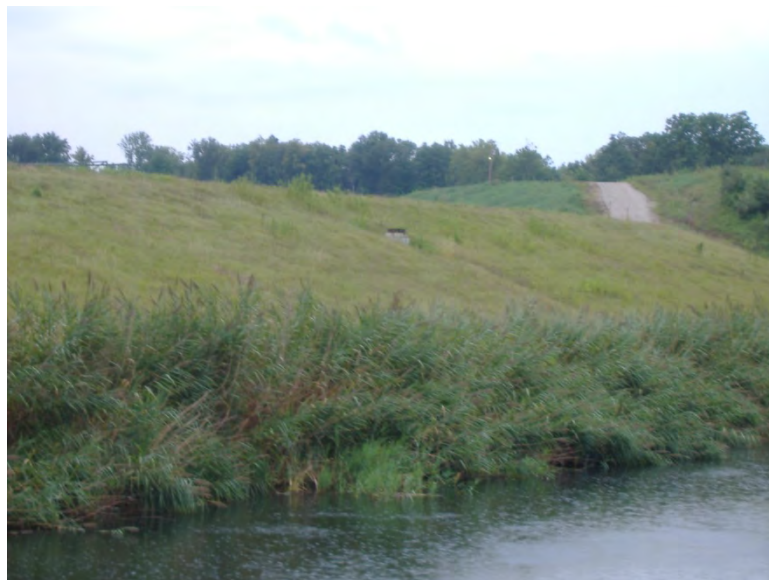
Figure 5.3.2-2: Photograph of the Inside Slope of the East Ash Pond System Secondary Cell Embankment.

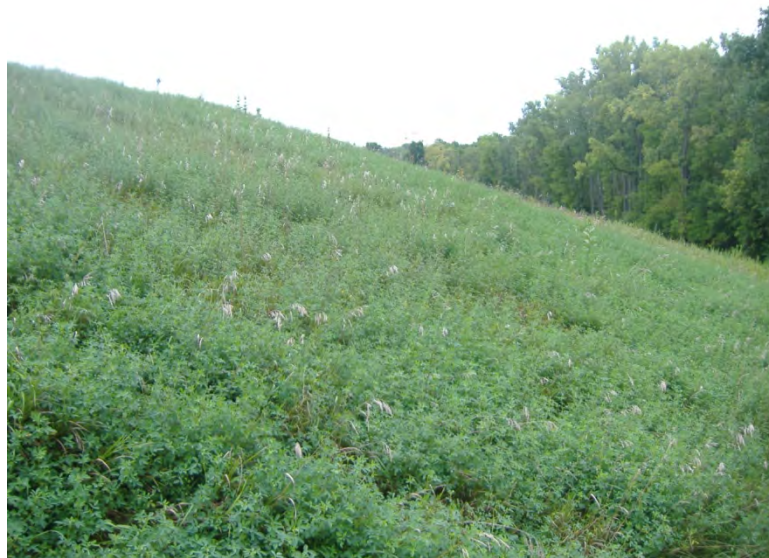
The outside slope of the embankment is vegetated with various species of tall grass and weeds. No major scarps, sloughs, bulging, cracks, depressions or other indications of slope instability, or signs of

uncontrolled seepage were observed. Figure 5.3.3-1 shows a representative section of the outside slope of the embankment.

Figure 5.3.3-1: Photograph of the Outside Slope of the East Ash Pond System Embankment.

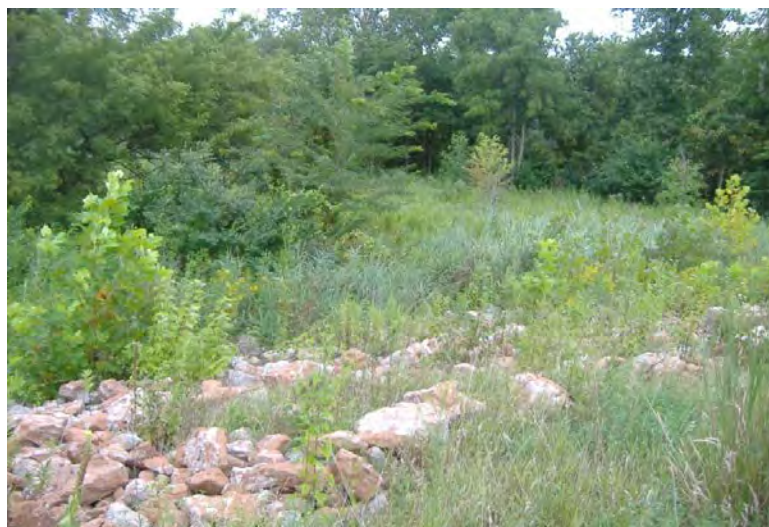
Most of the toe of the embankment is densely vegetated with various species of trees, grass, and weeds. In some sections, the toe is also armored with riprap. Figure 5.3.3-2 shows a portion of the toe that is armored with riprap and also covered in dense vegetation.

Figure 5.3.3-2: Photograph of Riprap and Vegetation at the Toe of the East Ash Pond System Embankment.

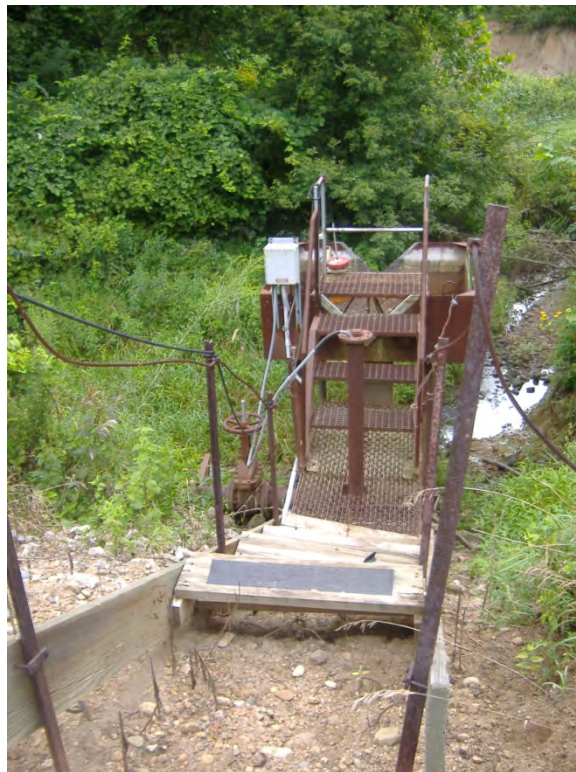
The North Ash Pond System overflow structure was observed to be working properly, discharging flow from the pond, and visually appeared to be in satisfactory condition. There was no sign of clogging of the spillway and the water exiting the outlet was flowing clear. Figure 5.4.1-1 shows the main outlet structure.

Figure 5.4.1-1: Photograph of the North Ash Pond System Overflow Structure.

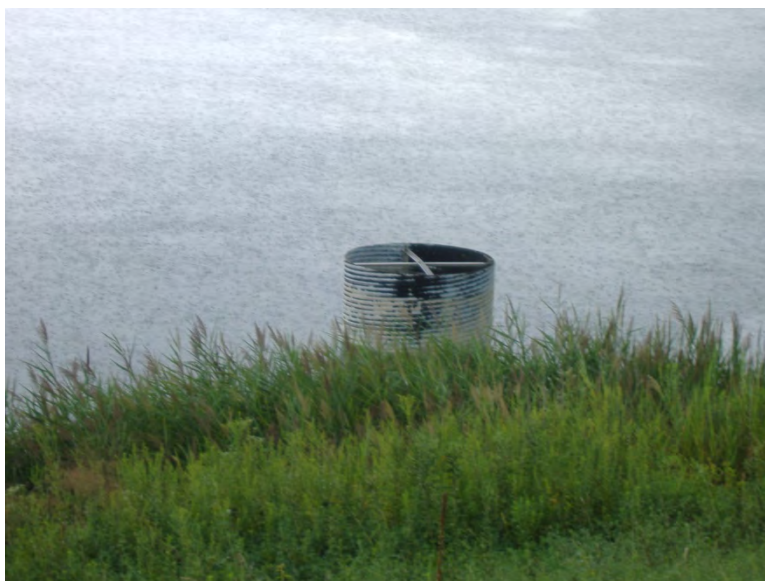
The East Ash Pond System overflow structure was observed to be working properly, discharging flow from the pond, and visually appeared to be in satisfactory condition. There was no sign of clogging of the spillway and the water exiting the outlet was flowing clear. Figure 5.4.1-2 shows the main outlet structure.

Figure 5.4.1-2: Photograph of the East Ash Pond System Primary Outfall Structure.

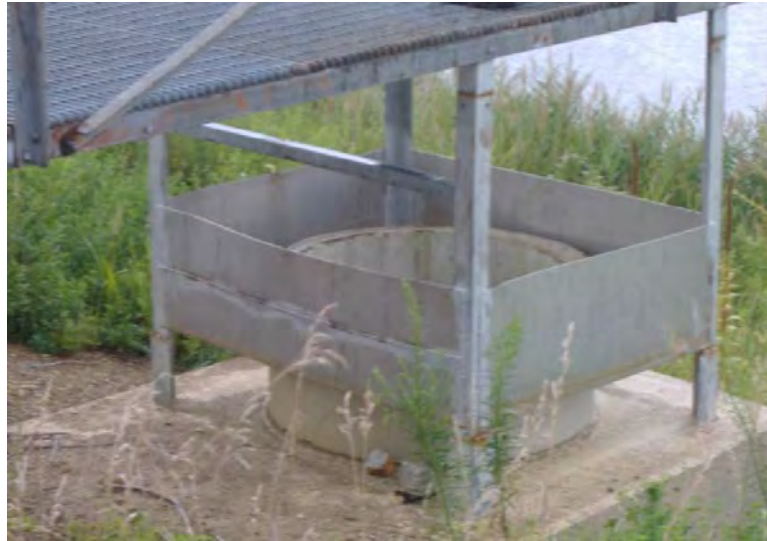
An emergency outfall pipe is present in the East Ash Pond System, directly below the primary outfall structure. Figure 5.4.1-3 shows the emergency outfall pipe.

Figure 5.4.1-3: Photograph of the East Ash Pond System Emergency Outfall Pipe.

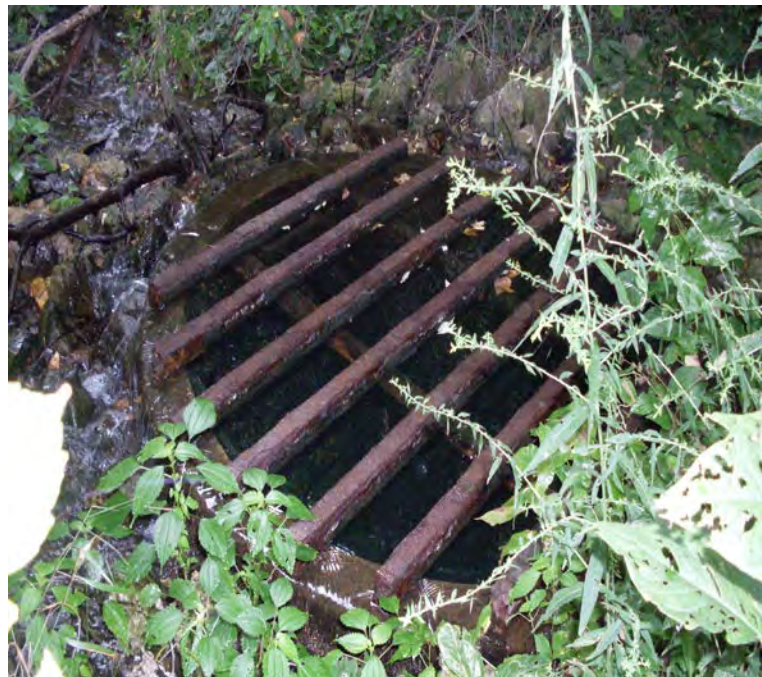
The outlet conduit appeared to be in good shape and operating normally with no sign of clogging and the water exiting the outlet was flowing clear. Figure 5.4.2-1 shows the spillway outfall pipe discharge.

The design of the spillway outfall pipe includes a vertical bend upward at the discharge end. The upward bend provides energy dissipation that reduces potential erosion along the receiving drainageway.

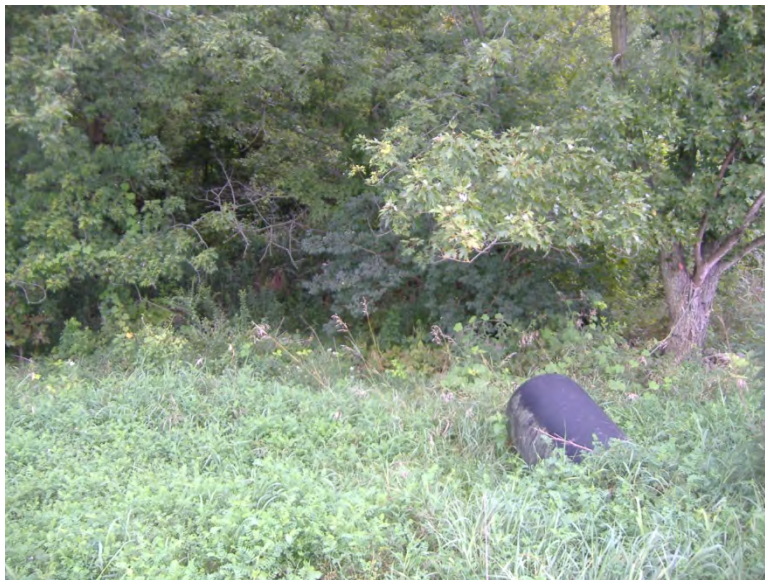
A corrugated metal pipe serves as the emergency spillway for the North Ash Pond System. The spillway has not been used in recent memory. Figure 5.4.3-1 shows the North Ash Pond System emergency spillway.

Figure 5.4.3-1: Photograph of the North Ash Pond System Emergency Spillway.
